SUBJECT: BMP Maintenance Inspection – Dry Extended Detention Basin (BMP #00500)

BMP Inspection
EAST HEMPFIELD TOWNSHIP

BMP Name/ID
BMP 500

Type
Dry Extended Detention Basin

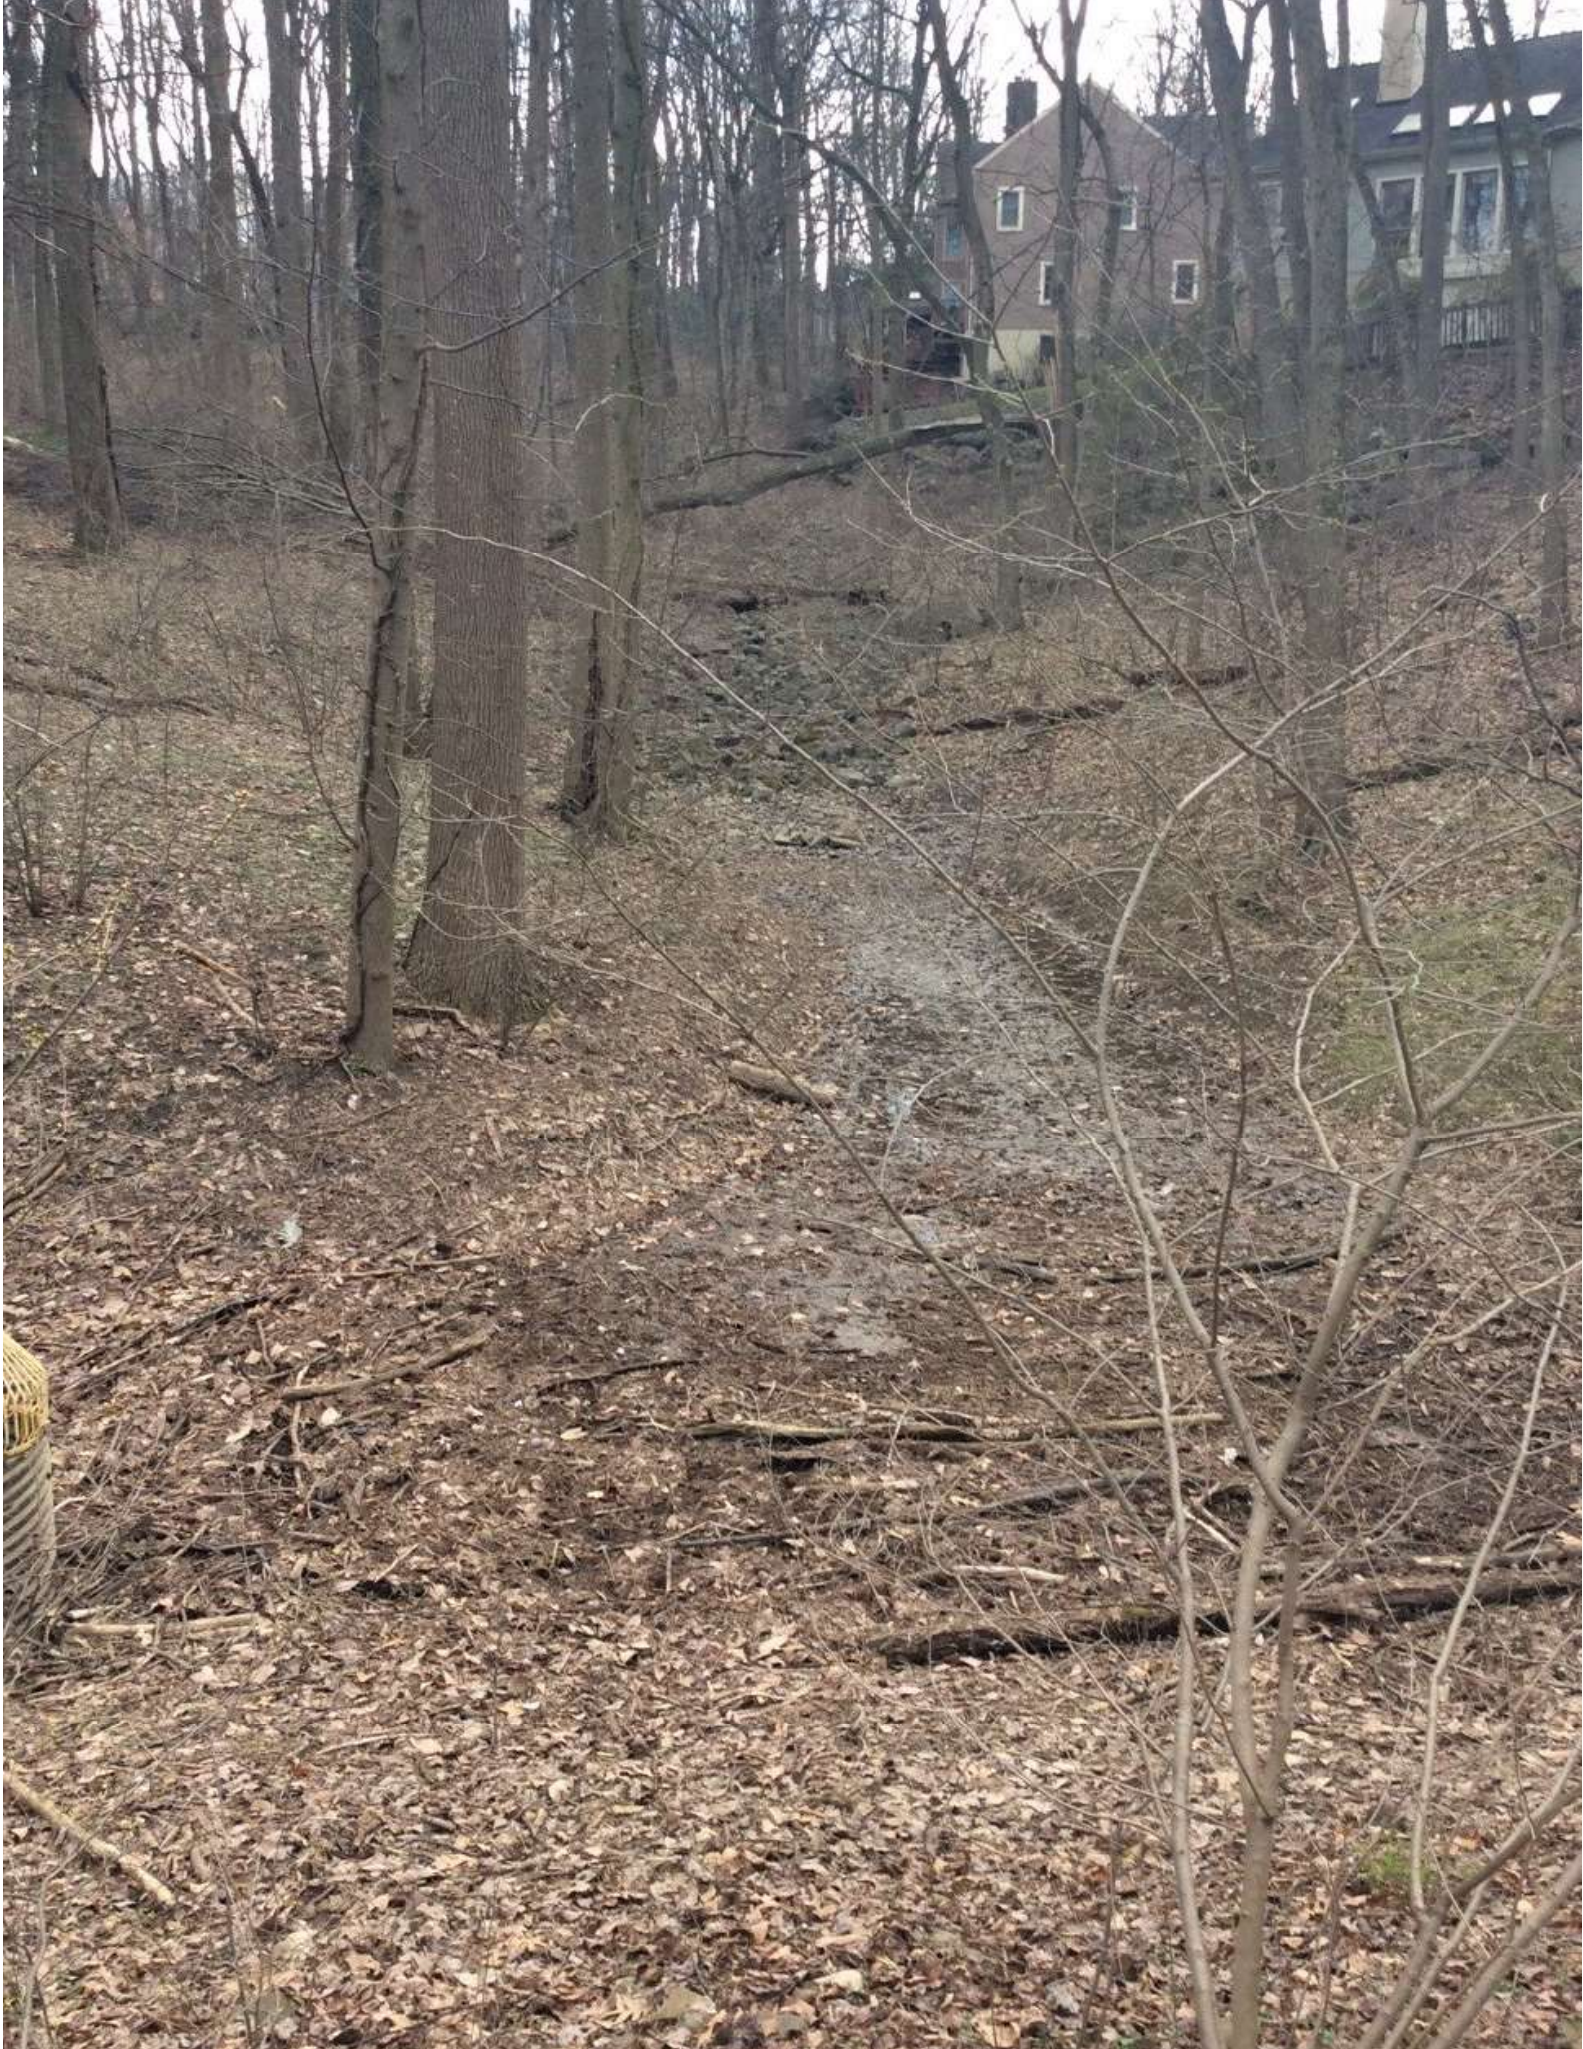
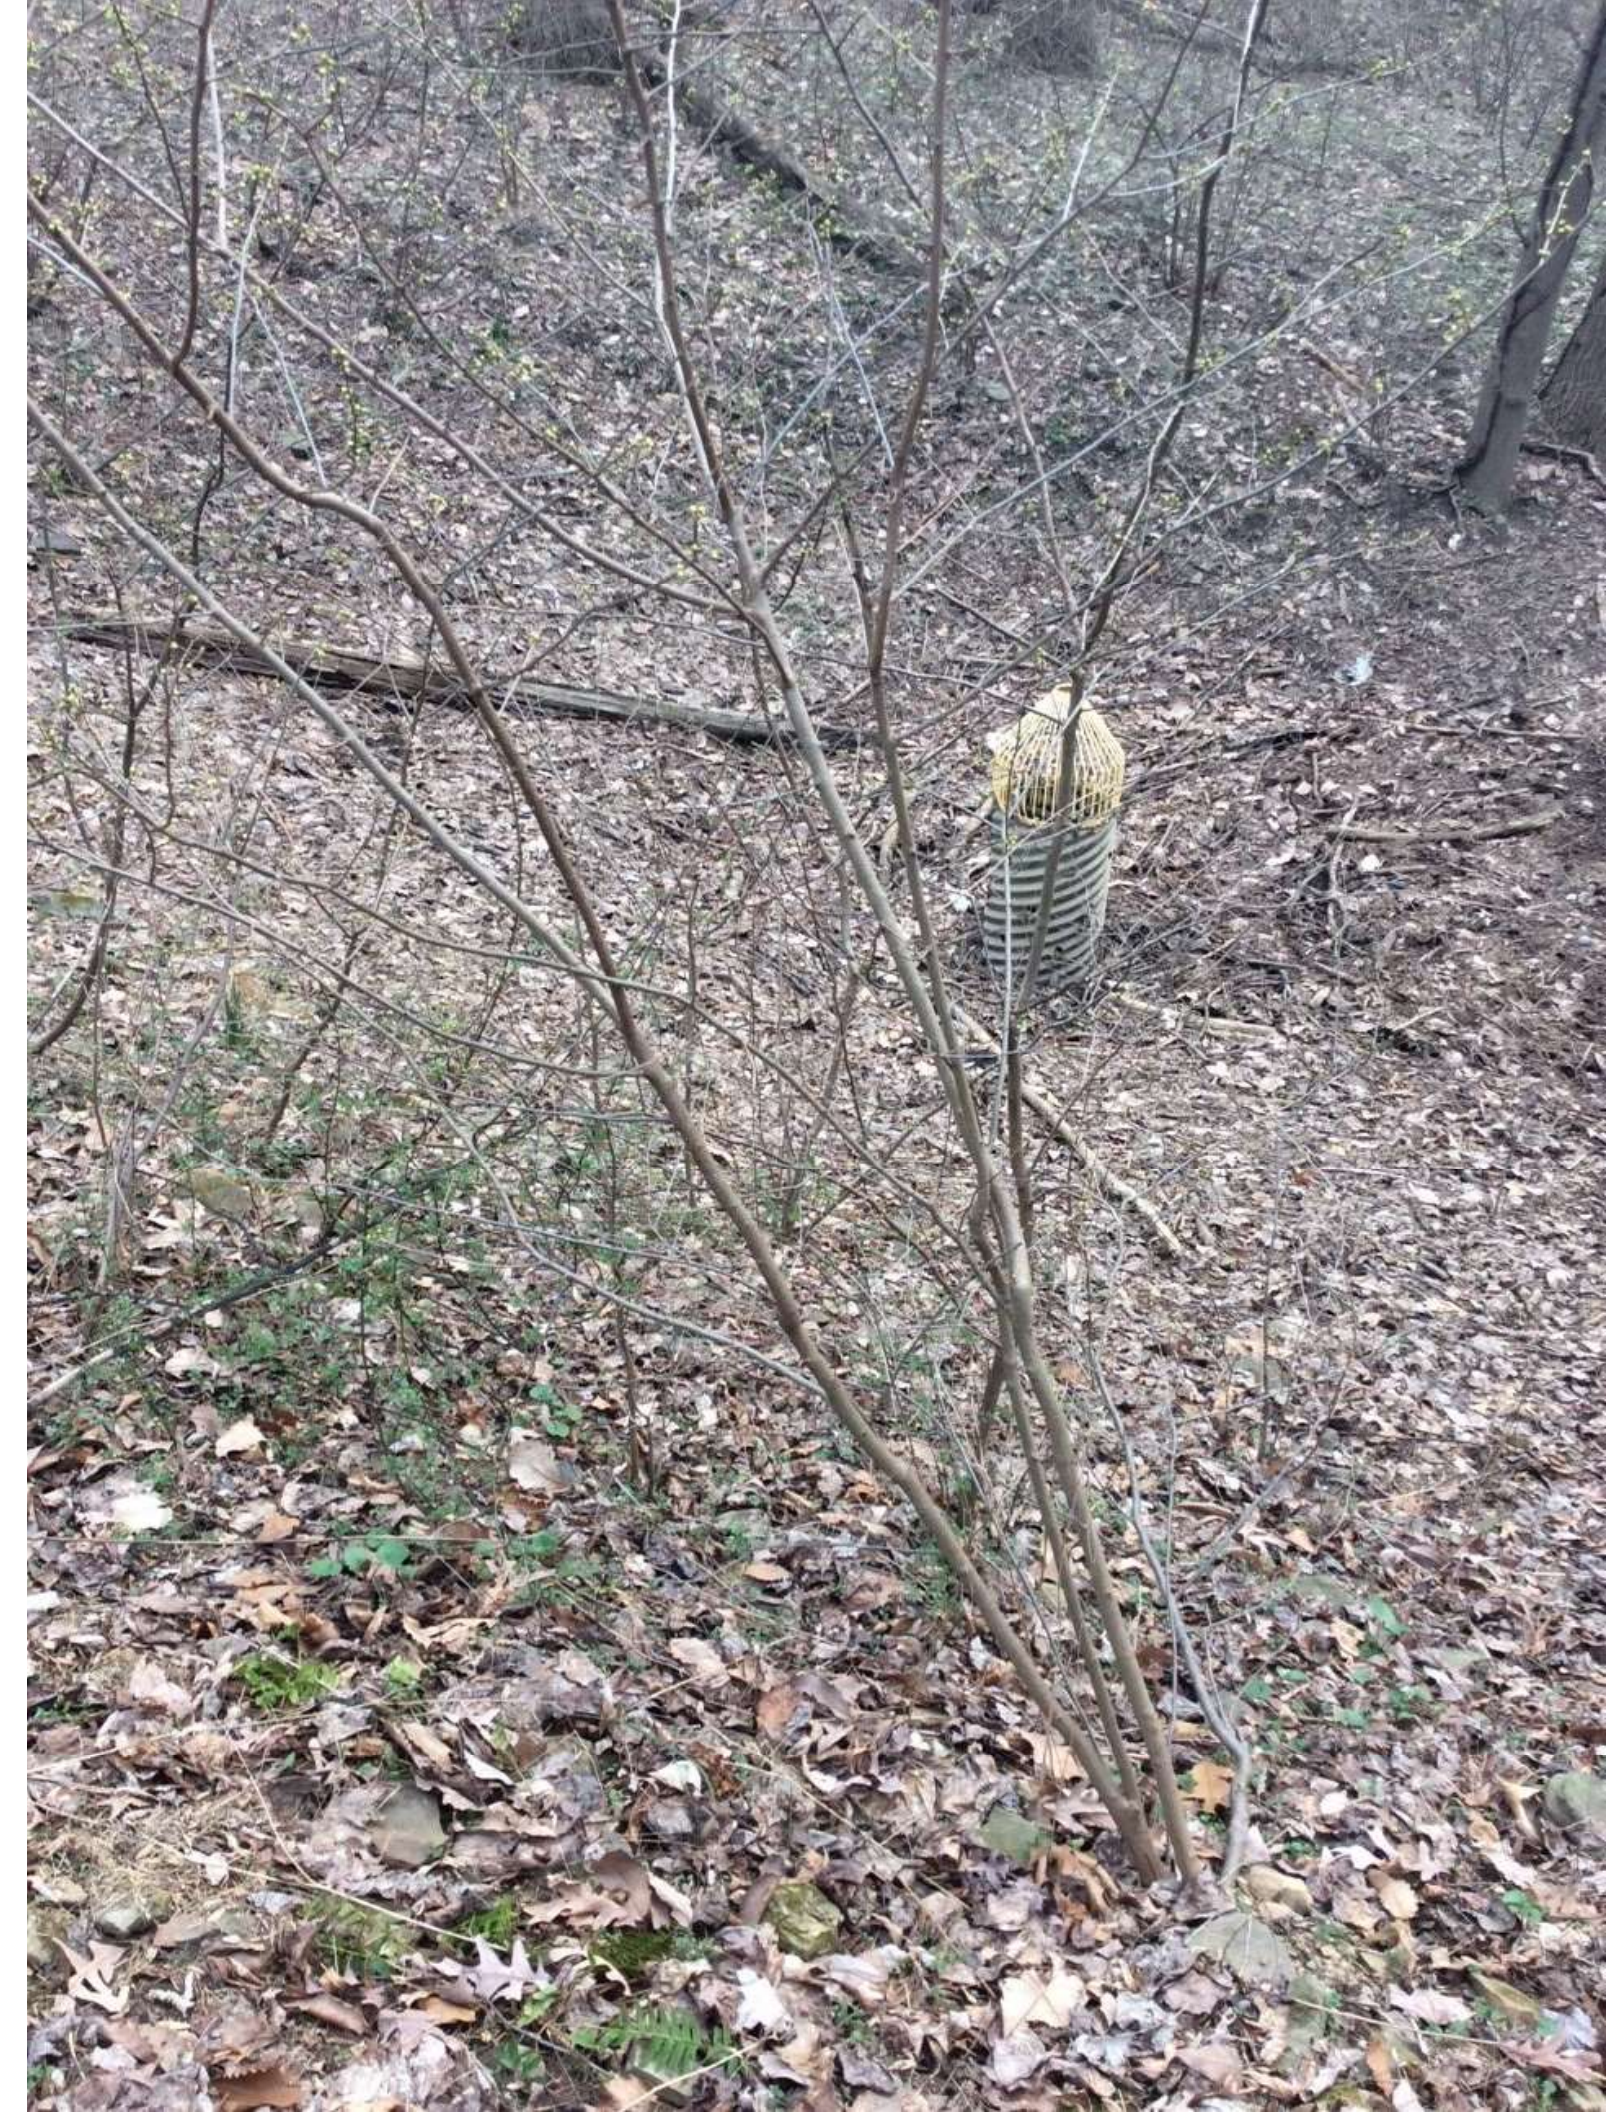
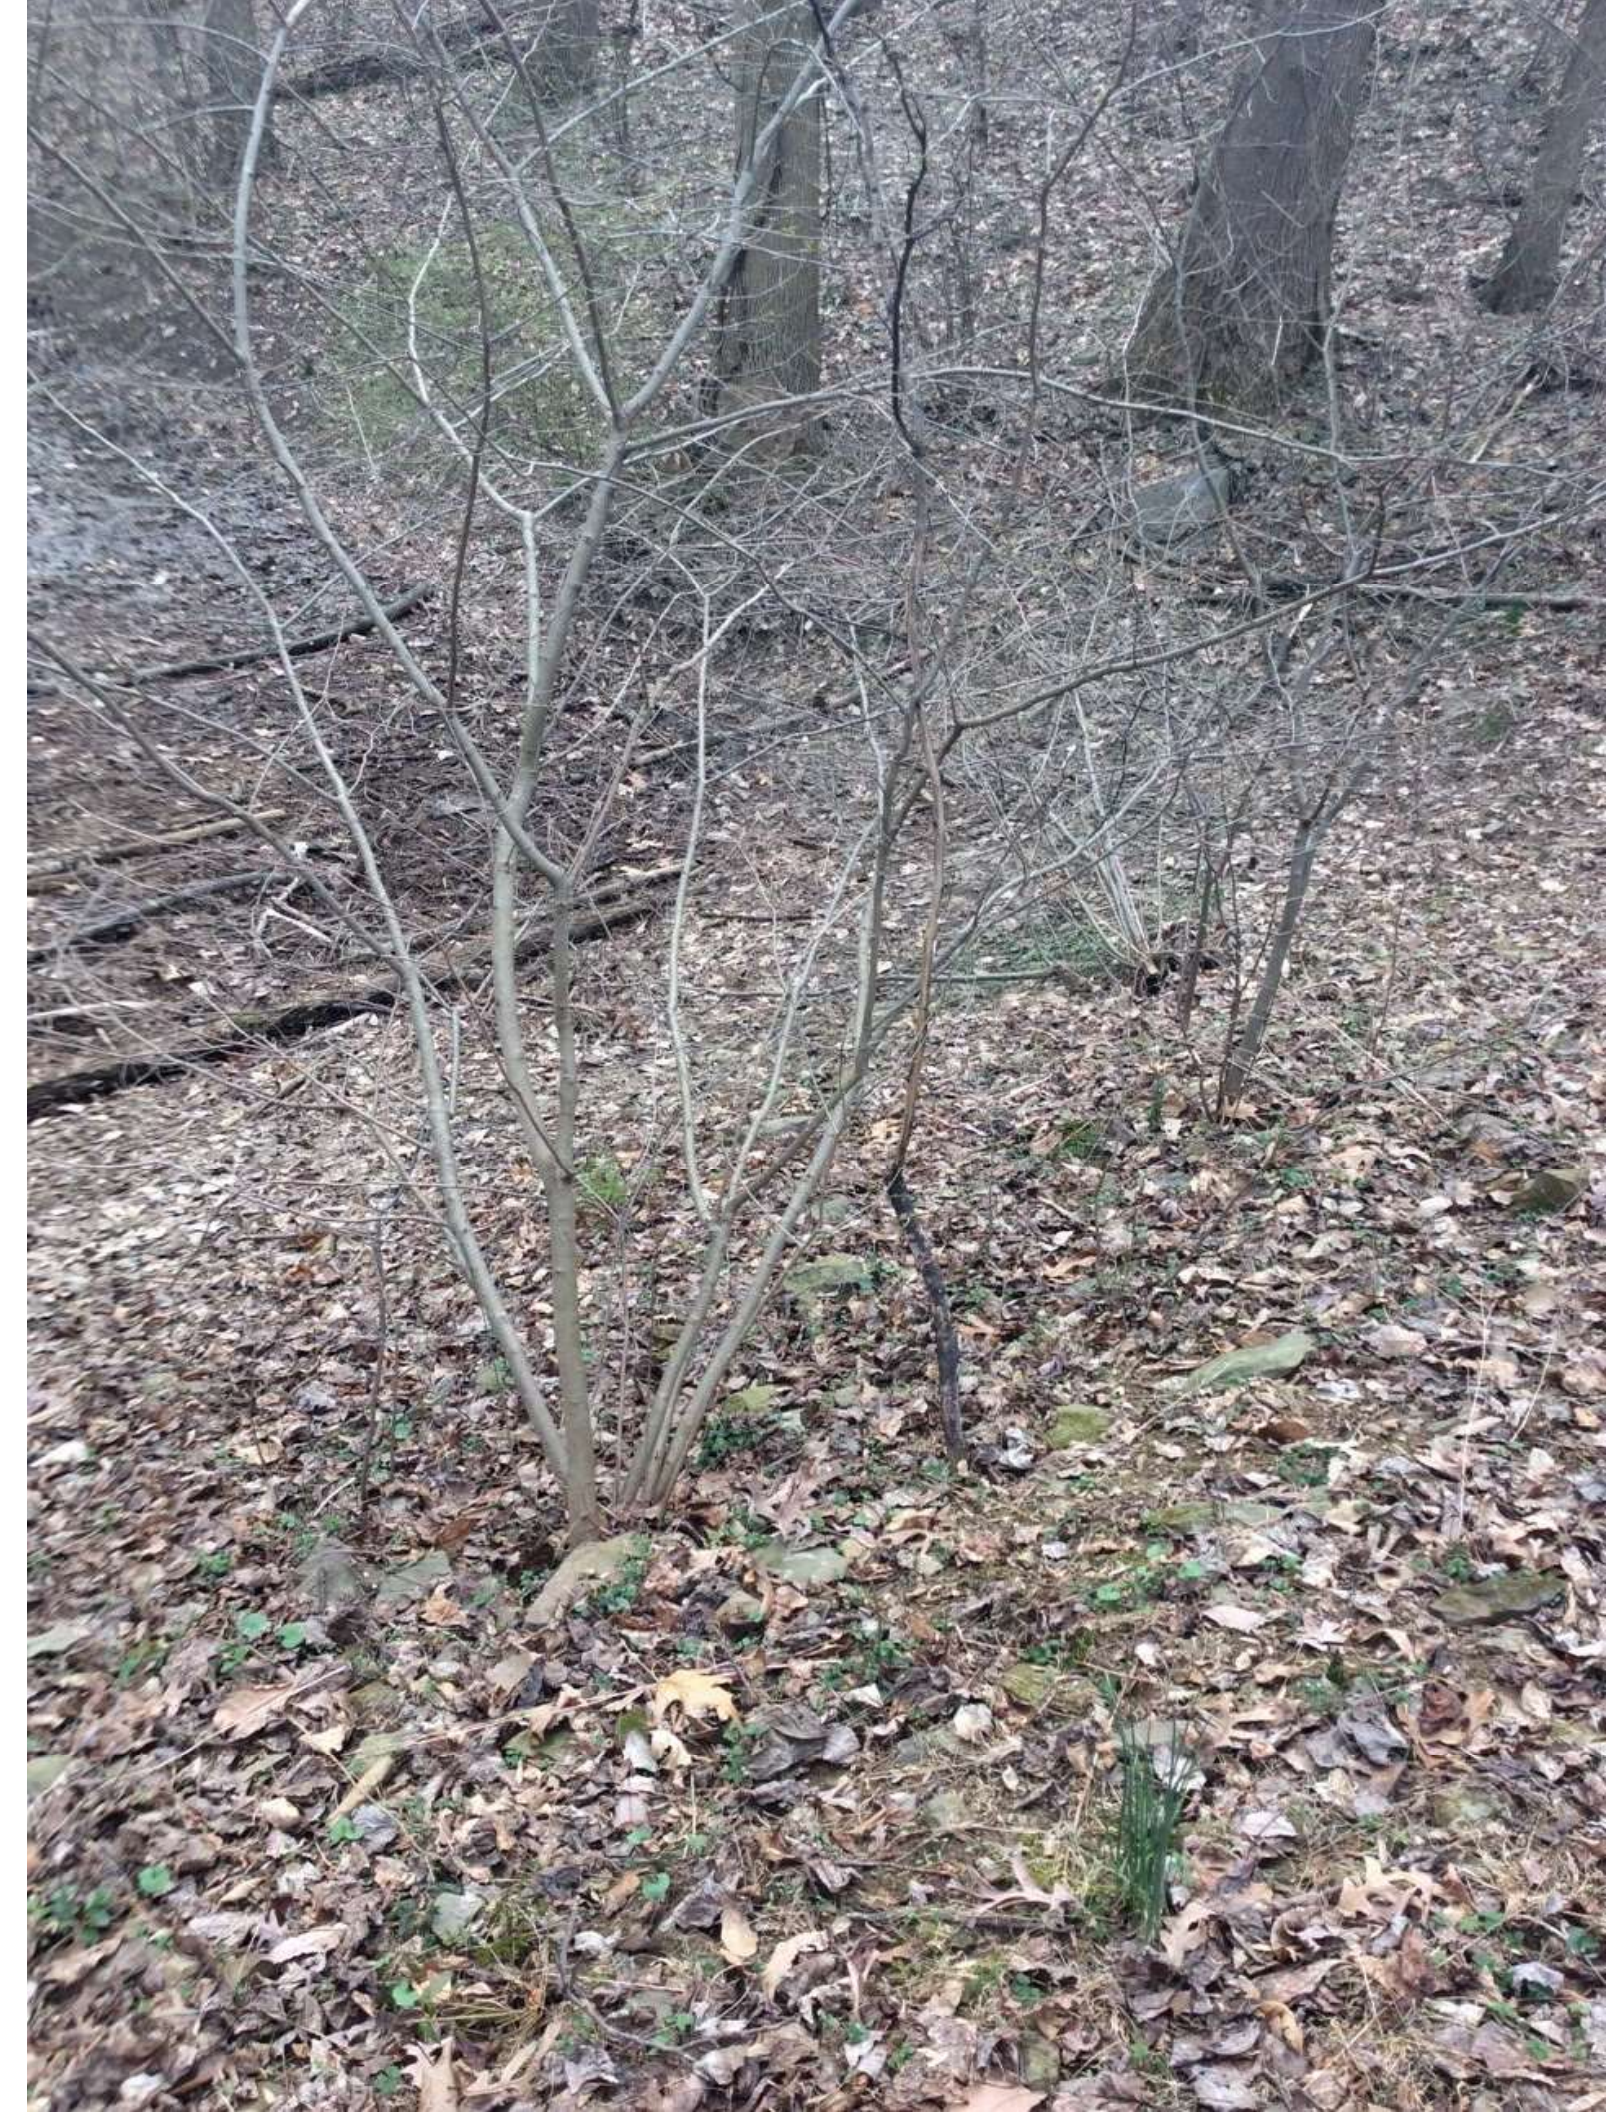
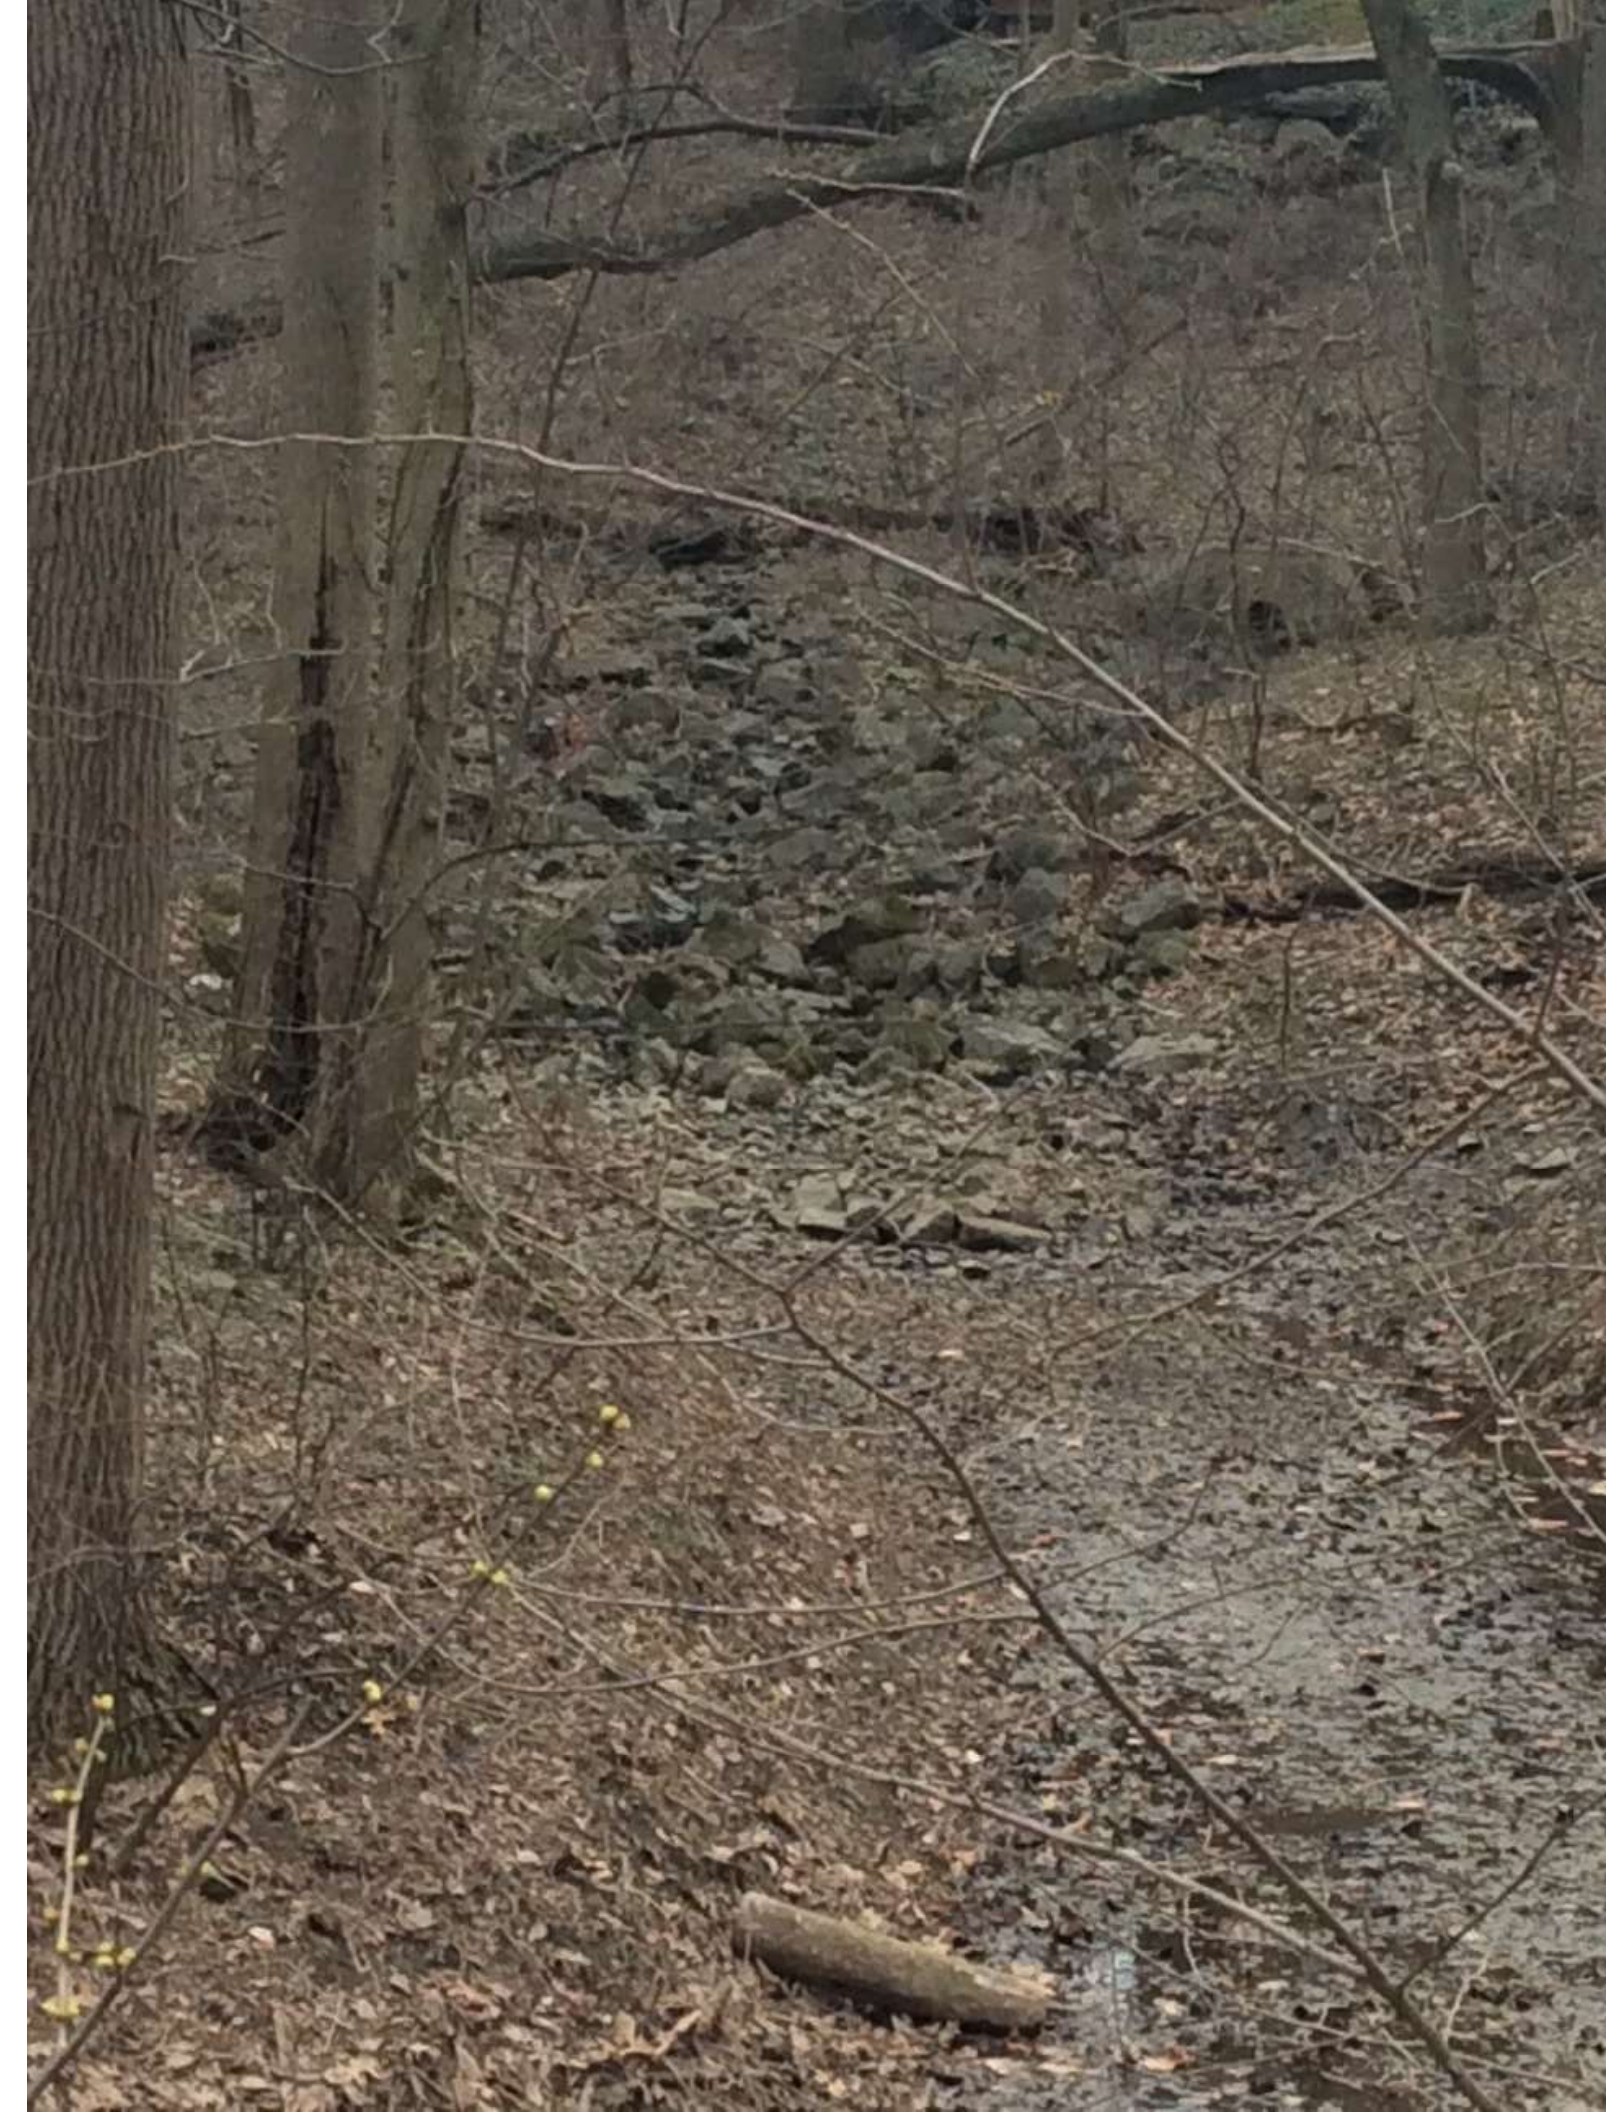
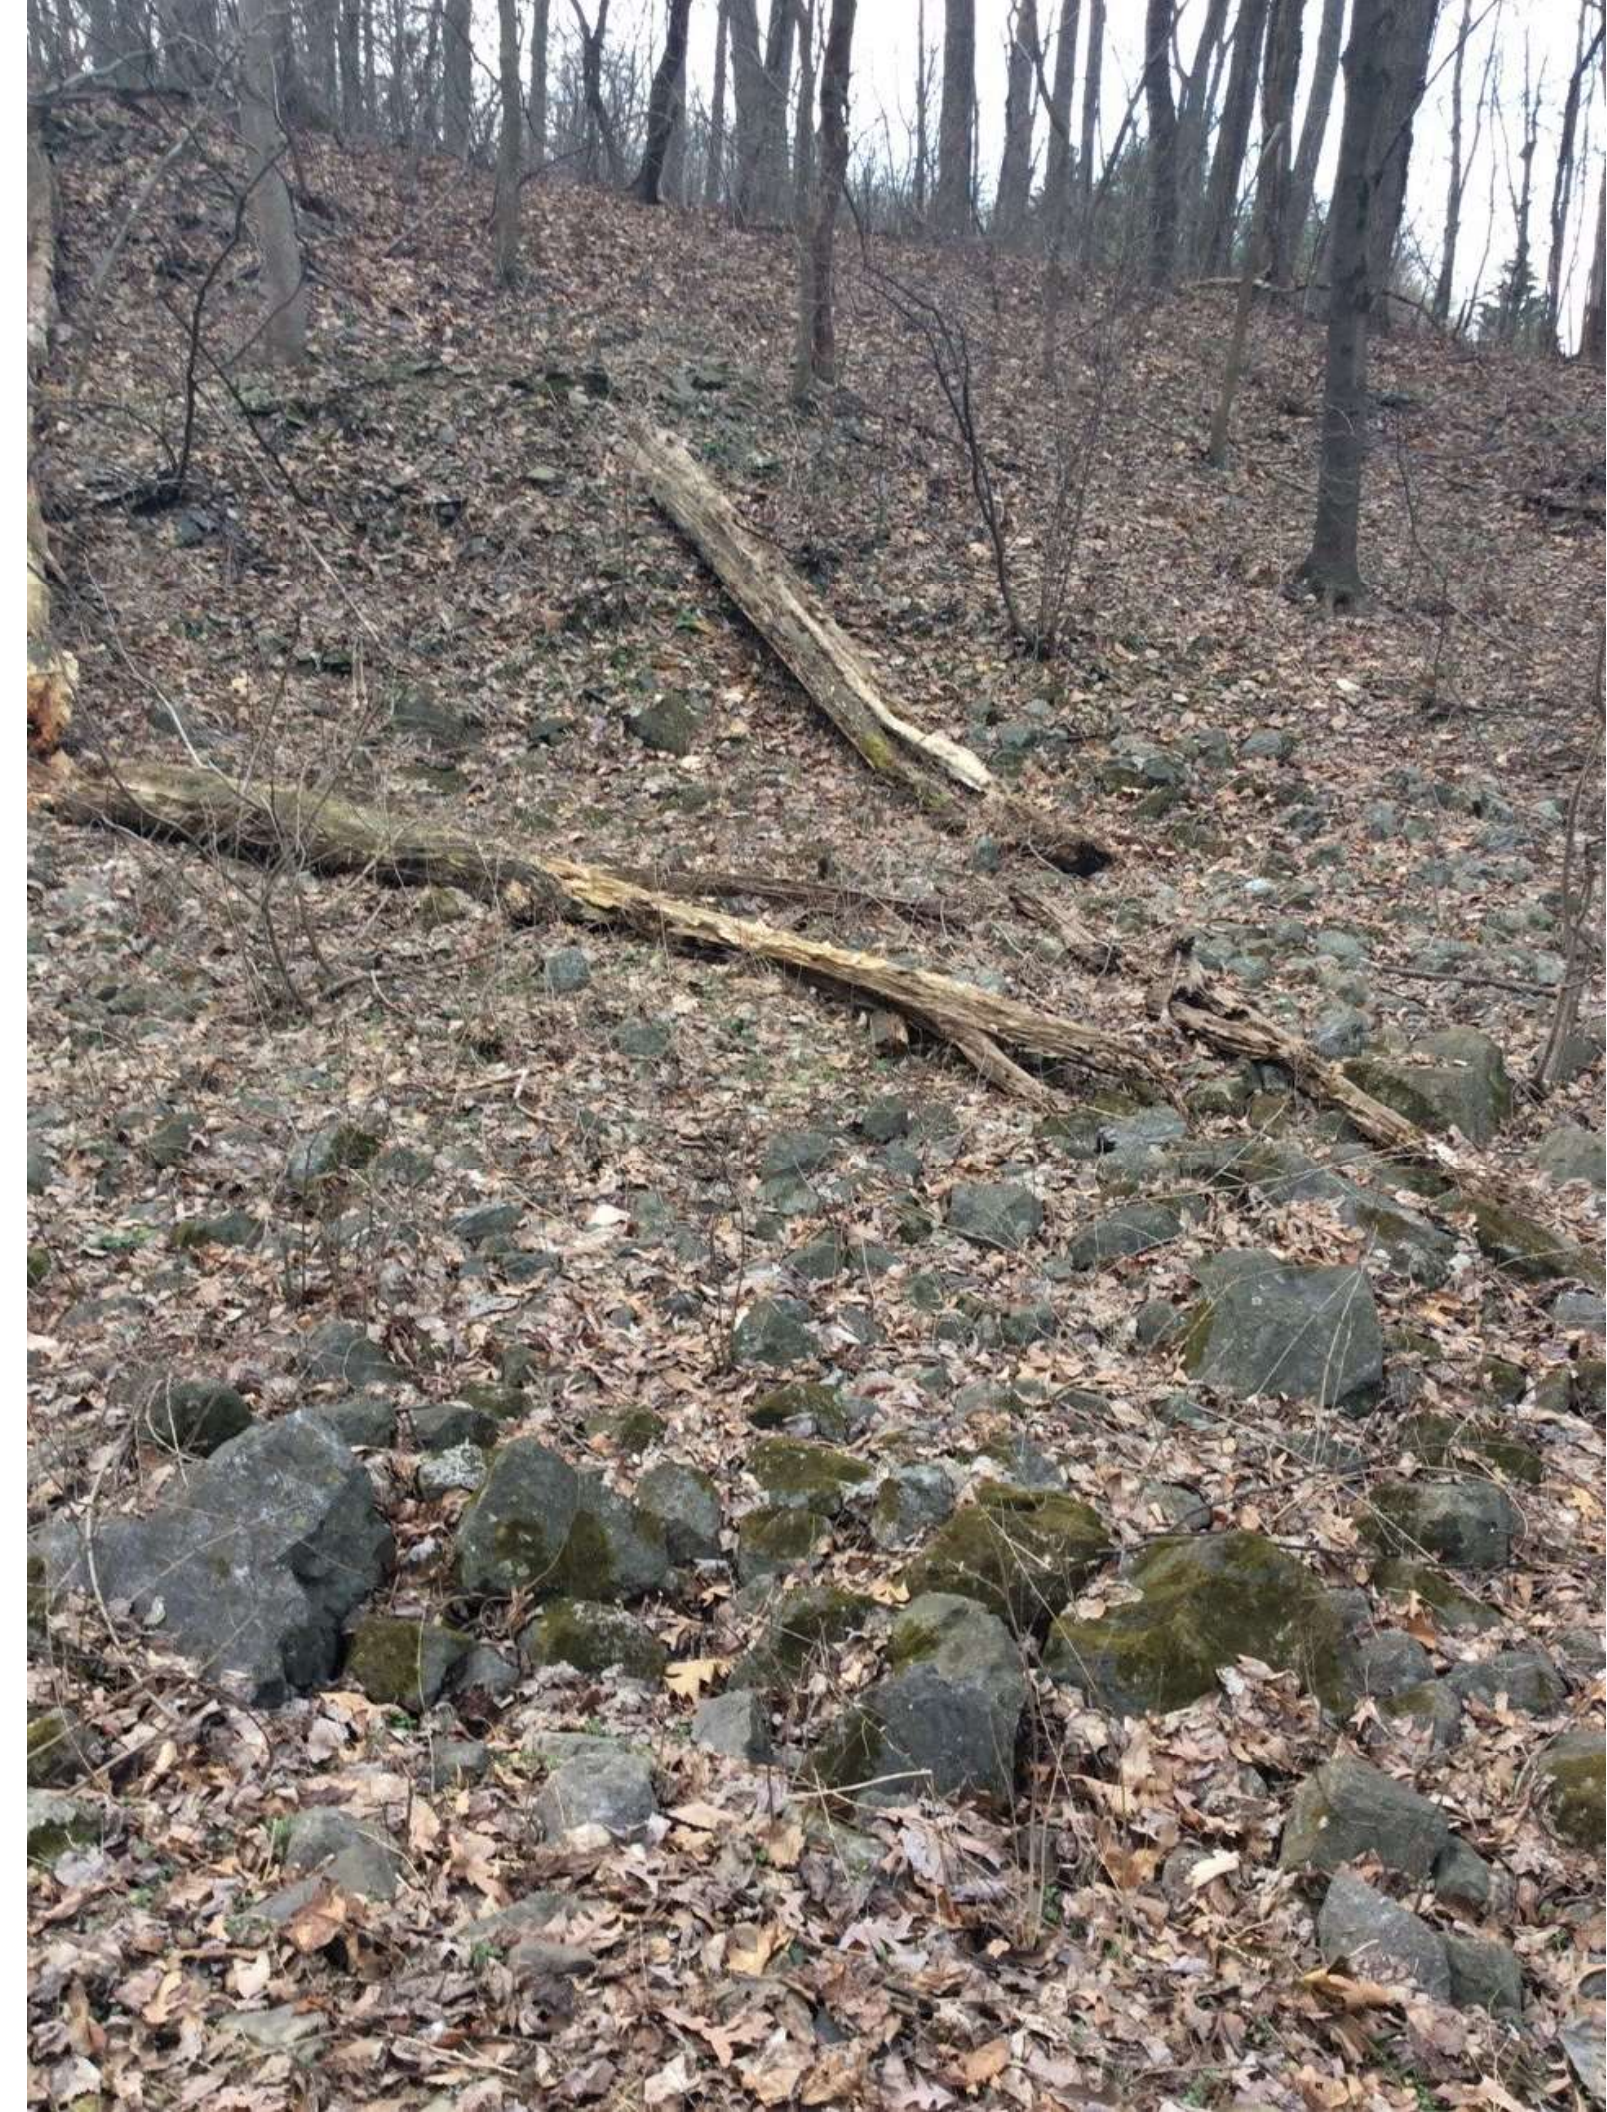
Spillway (Fair)

Sediment and Debris Accumulation (Fair)

Invasive or Unwanted Growth? (Fair)

1. Follow up: Remove shrubs/woody vegetation from banks of the berm and any vegetation from the emergency spillway. .
2. Follow up: Remove woody debris and downed trees within the rip rap entry swale and emergency spillway.
3. Follow up: Remove accumulated debris and sediment from basin bottom.
4. Follow up: Remove sediment and smaller rocks from end of inlet swale, and restore appropriately sized rip rap.
5. Monitoring: Yearly monitoring should be done to assess sediment buildup and any tree debris.
